SILICON NITRIDE IN ROLLING CONTACT BEARINGS

NORTON Co.

PREPARED FOR
NAVAL AIR SYSTEMS COMMAND

FINAL REPORT
Contract N00019-73-C-0193
January 3, 1973 to October 3, 1973

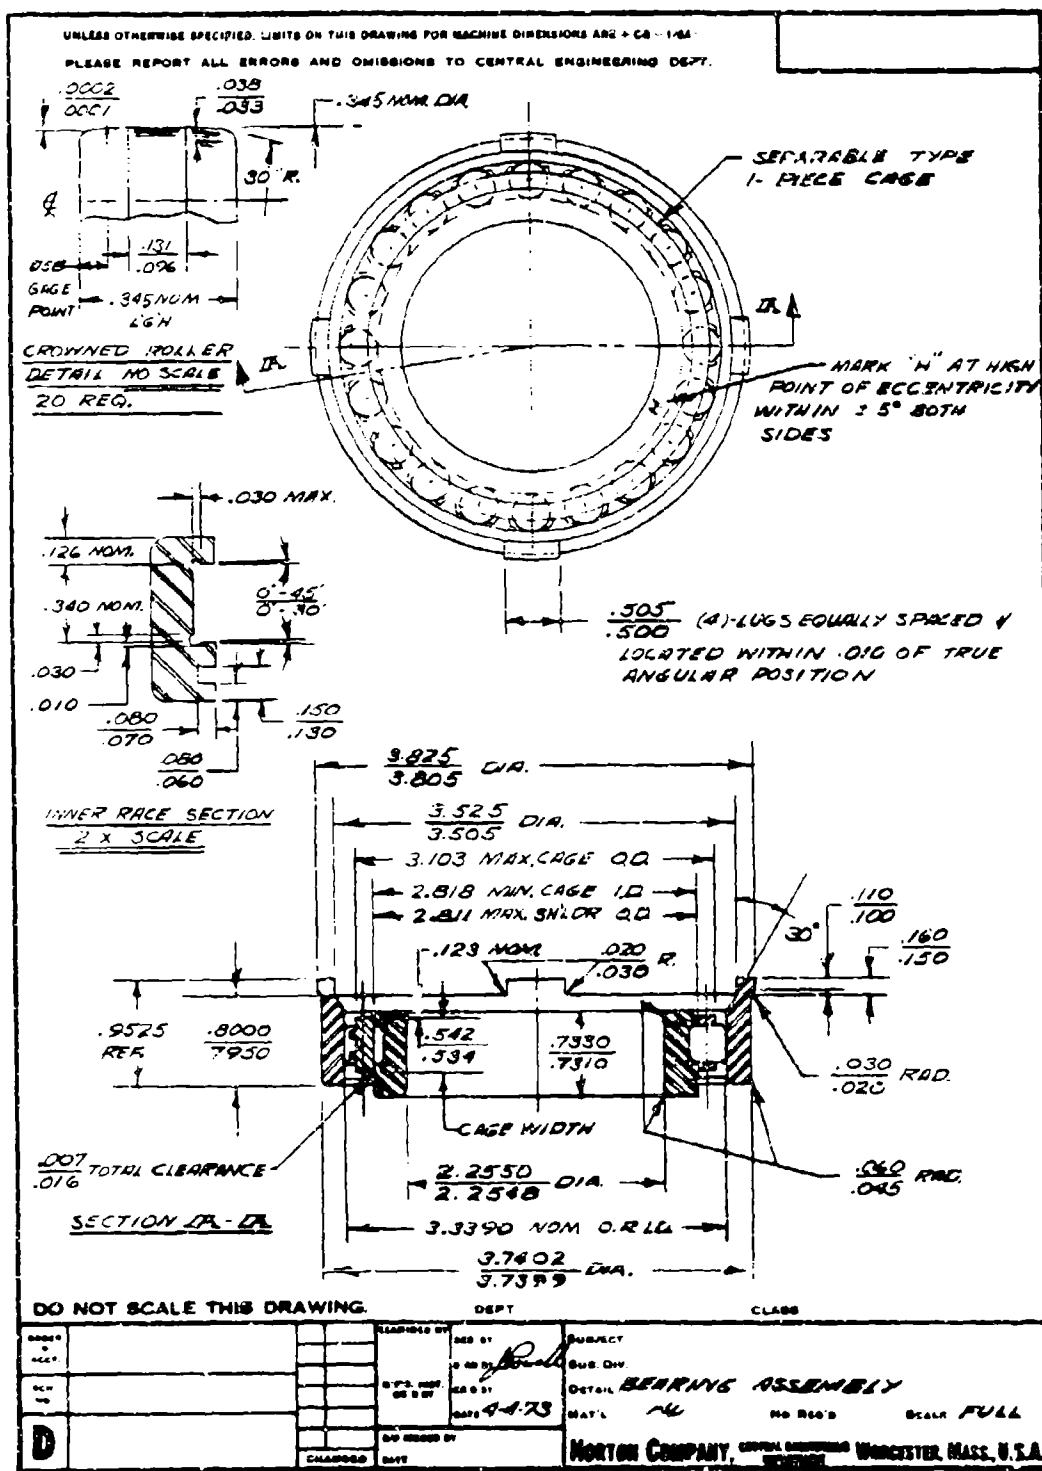
FIGURE 19 - Design for Bearing with Steel Races and Silicon Nitride Rollers.

The NC-132 silicon nitride roller stock was qualified as covered in Section II E1. The fabrication of the silicon nitride rollers was accomplished in two phases. The first phase proceeded by the following steps: Bar stock, 6" x 7/16" x 7/16", was taken from a square to round cross section with a 120 grit diamond, resinoid bonded wheel on an O.D. grinder. The rods were reduced in diameter on a centerless grinder, employing a 220 grit diamond, resinoid bonded wheel. A total of approximately 0.030 inch was removed in steps and the wheel allowed to run-out on the final passes. A hand held, cast iron ring lap was used to remove a maximum of 0.0002 inch while the rod rotated in a chuck at 200 rpm.

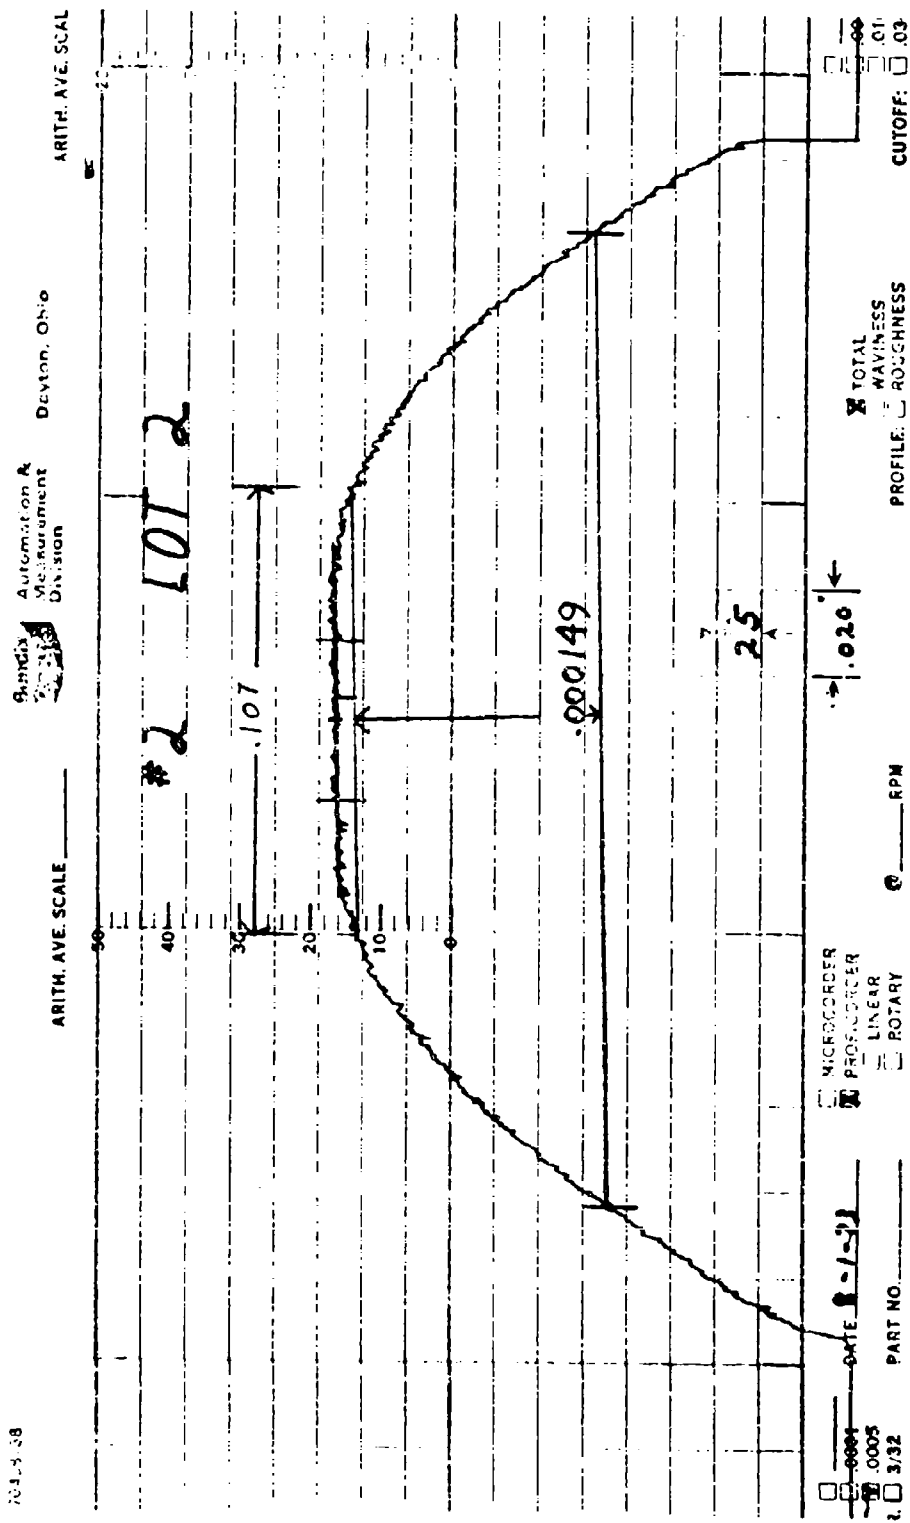
FIGURE 21 - Linear Proficorder Trace Across a Silicon Nitride Roller (Acceptable Contour).

A sampling of the 120 finished and sized blanks was made for diameter and specific crown characteristics (see Table XII). A typical rotary proficording of a sample roller is shown in Figure 23. Overall, the rollers are to print tolerances with the exception of the maximum diameter variation within a group of 20 rollers and crown flat taper. The diameters are measured at the center of the roller lengths. Within one group, the diameter of two rollers differ by as much as 115 millionths of an inch from the low diameter of one to the high diameter of the other. However, if the average diameters of each respective roller are considered, the maximum variation is within the 50 millionths of an inch allowed.

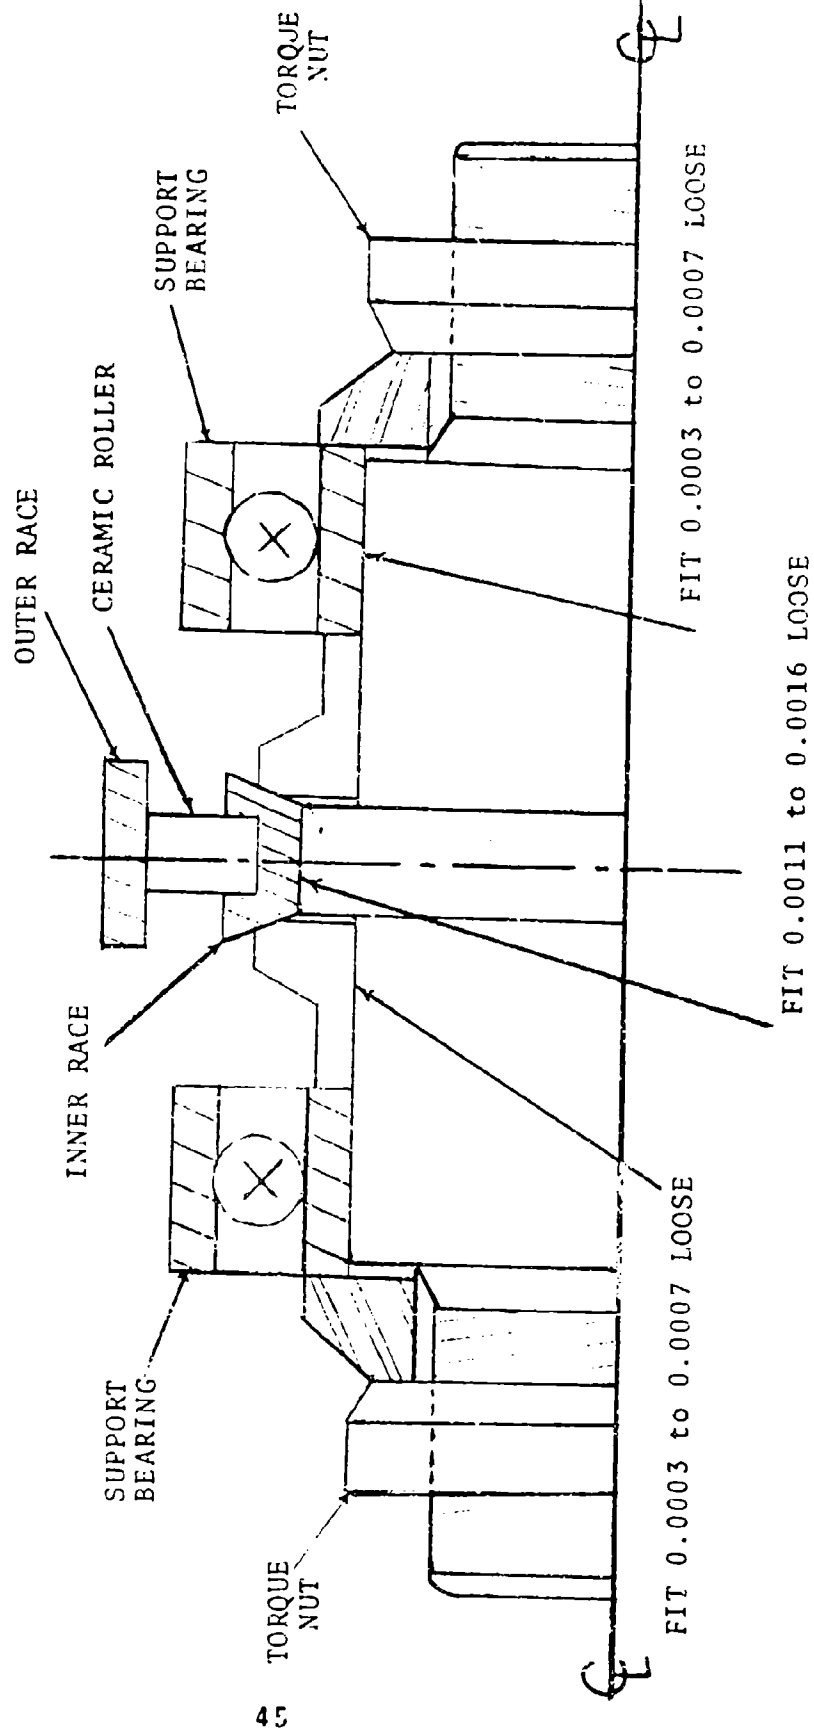
FIGURE 28 - Method Used to Hold Ceramic Race to Shaft

turning on the shaft. With a silicon nitride race (coefficient of thermal expansion $1.77 \times 10^{-6}/^{\circ}\text{F}$) and a steel shaft (coefficient of thermal expansion $6.5 \times 10^{-6}/^{\circ}\text{F}$) the interference fit would increase due to the shaft expansion. An increase in fit would increase the inner races hoop stresses, possibly reduce fatigue life, and may eventually fracture the race. In order to prevent this condition from occurring a mounting scheme shown in Figure 28 was employed.
